DEPARTMENT OF TRANSPORTATION

Quality Assurance and Source Inspection

Contract #: 04-0120F4Cty: SF/ALA Rte: 80 PM: 13.2/13.9File #: 99.28**WELDING INSPECTION REPORT****Resident Engineer:** Casey, William**Address:** 333 Burma Road**City:** Oakland, CA 94607**Report No:** WIR-027164**Date Inspected:** 09-Feb-2012**Project Name:** SAS Superstructure**OSM Arrival Time:** 700**Prime Contractor:** American Bridge/Fluor Enterprises, a JV**OSM Departure Time:** 1530**Contractor:** L&M Industrial Fabricators**Location:** Tangent, OR**CWI Name:** Thomas Dreyer**CWI Present:** Yes No**Inspected CWI report:** Yes No N/A**Rod Oven in Use:** Yes No N/A**Electrode to specification:** Yes No N/A**Weld Procedures Followed:** Yes No N/A**Qualified Welders:** Yes No N/A**Verified Joint Fit-up:** Yes No N/A**Approved Drawings:** Yes No N/A**Approved WPS:** Yes No N/A**Delayed / Cancelled:** Yes No N/A**Bridge No:** 34-0006**Component:** CCO 196 and 203**Summary of Items Observed:**

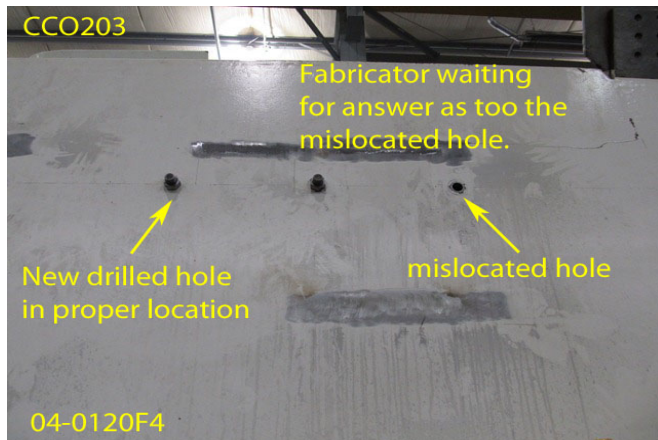
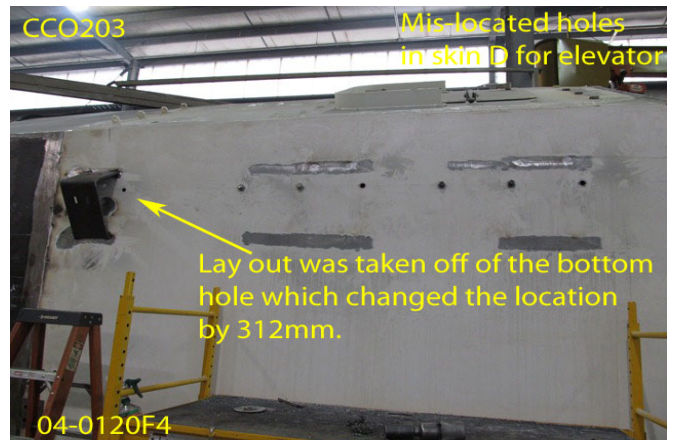
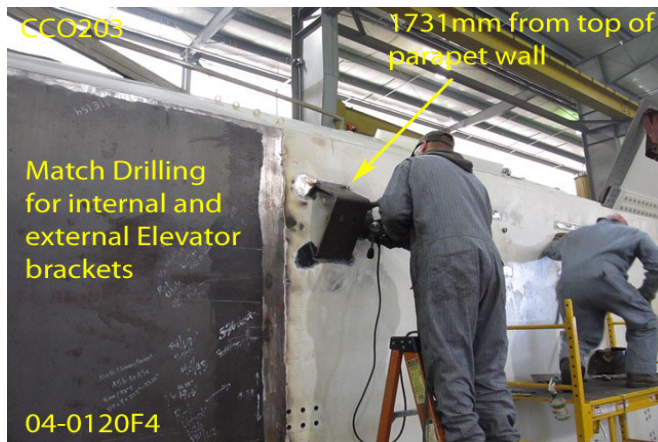
The QAI observed that PSI QC inspector Leo Jim was onsite to perform Magnetic Particle (MT) and Ultrasonic Testing (UT) on tower head to parapet weld A6B. The location is where a longitudinal indication was previously discovered during the MT testing. This QAI observed the testing and was informed that both methods for this repair was acceptable. This QAI then proceeded to perform a QA review also using the MT and UT method and found no rejectable indications at the time of the review. For further information please see TL-6027 and TL-6028 dated for today. At the time of the observations no issues were noted by the QAI.

(Welder ID #16) and Jake Schuld were fitting and drilling the internal and external elevator brackets. The fabricator was using a Mag-Drill with a 23mm size bit for the holes. During the drilling it was discovered that the layout was wrong for the brackets and that the dimension had been taken from the bottom hole located at 1731mm instead of the top at 1419mm. This has caused the layout to be off by 312mm. there 4 additional holes at each location for the external and internal brackets (total of 8 holes). These are located on skin D (4) and the internal stiffener (4). The fabricator QC Inspector Tom Dreyer has contacted the contractor ABF who is sending a Request For Information (RFI) to the Caltrans Engineer for resolution.
